Supermarket Fire Claims the Life of One Career Fire Fighter and Critically Injures Another Career Fire Fighter - Arizona

Fatality Assessment and Control Evaluation Investigative Report #F2001-13

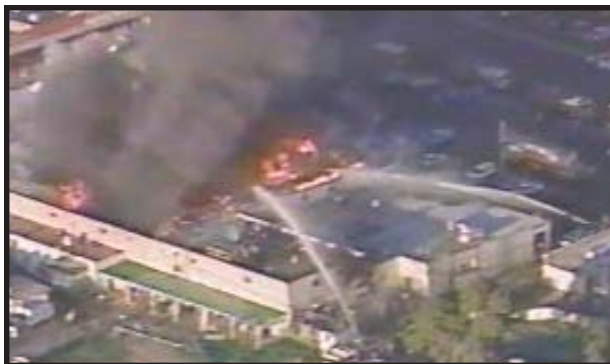
Aerial View of the Incident.

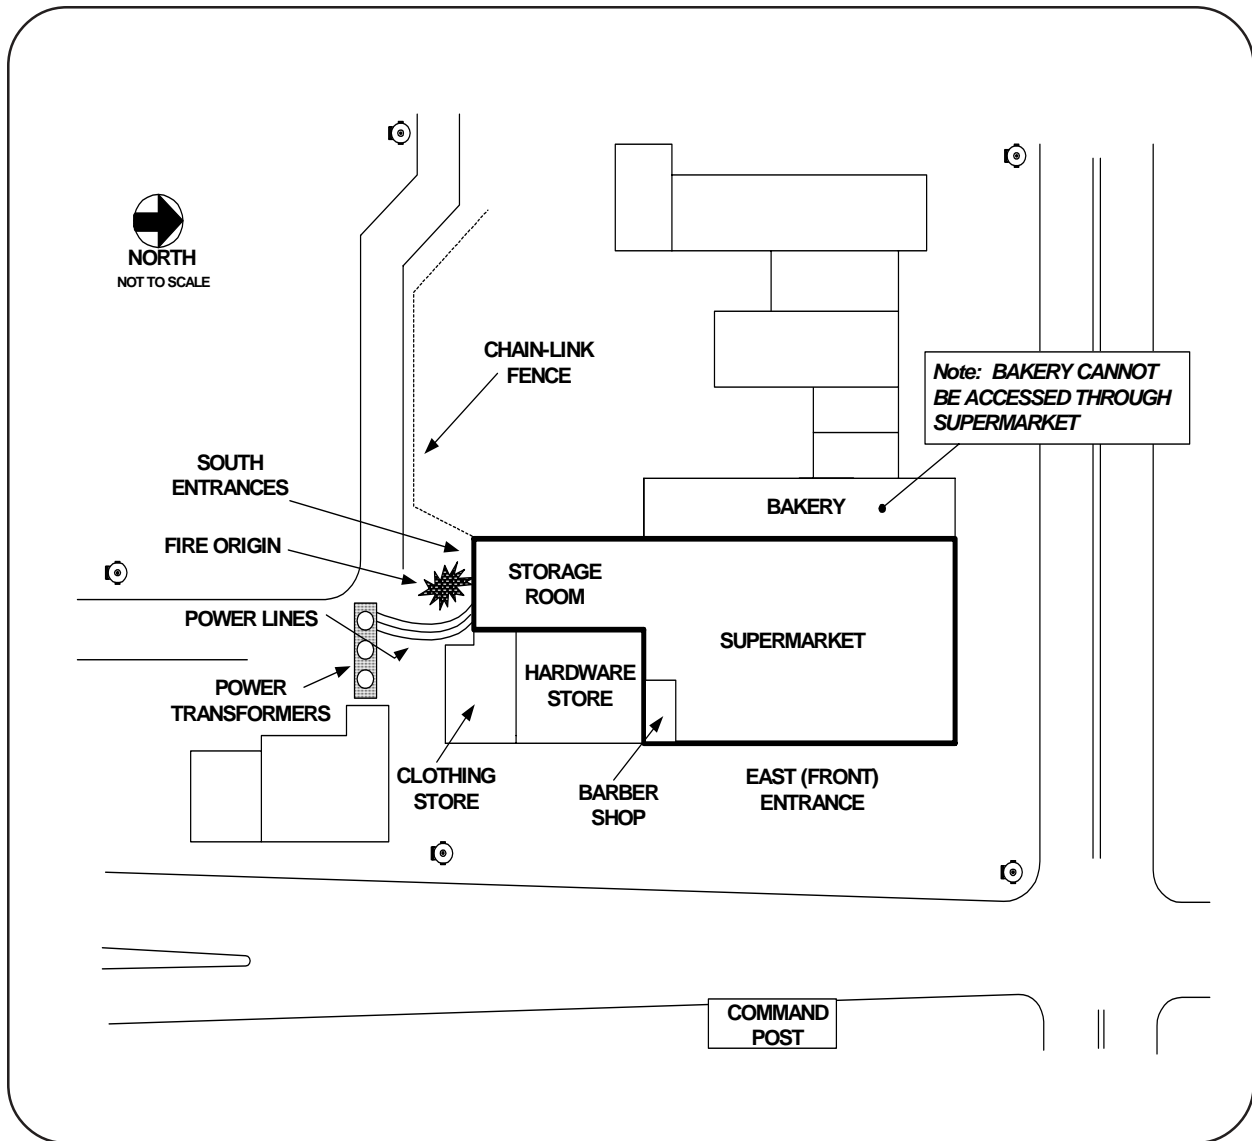
Diagram 1. Strip Mall Layout

Structure. The structure was a 27,905-square-foot, L-shaped supermarket that was part of a strip mall (Diagram 1). The structure had a slab concrete foundation and masonry block walls with steel beams and posts. The roof system consisted of open web steel trusses covered with wood, foam, and tar asphalt roofing. The ceiling height throughout the supermarket and lower-level storage area was approximately 20 feet. Second-floor platforms located above the coolers and the first-floor storage

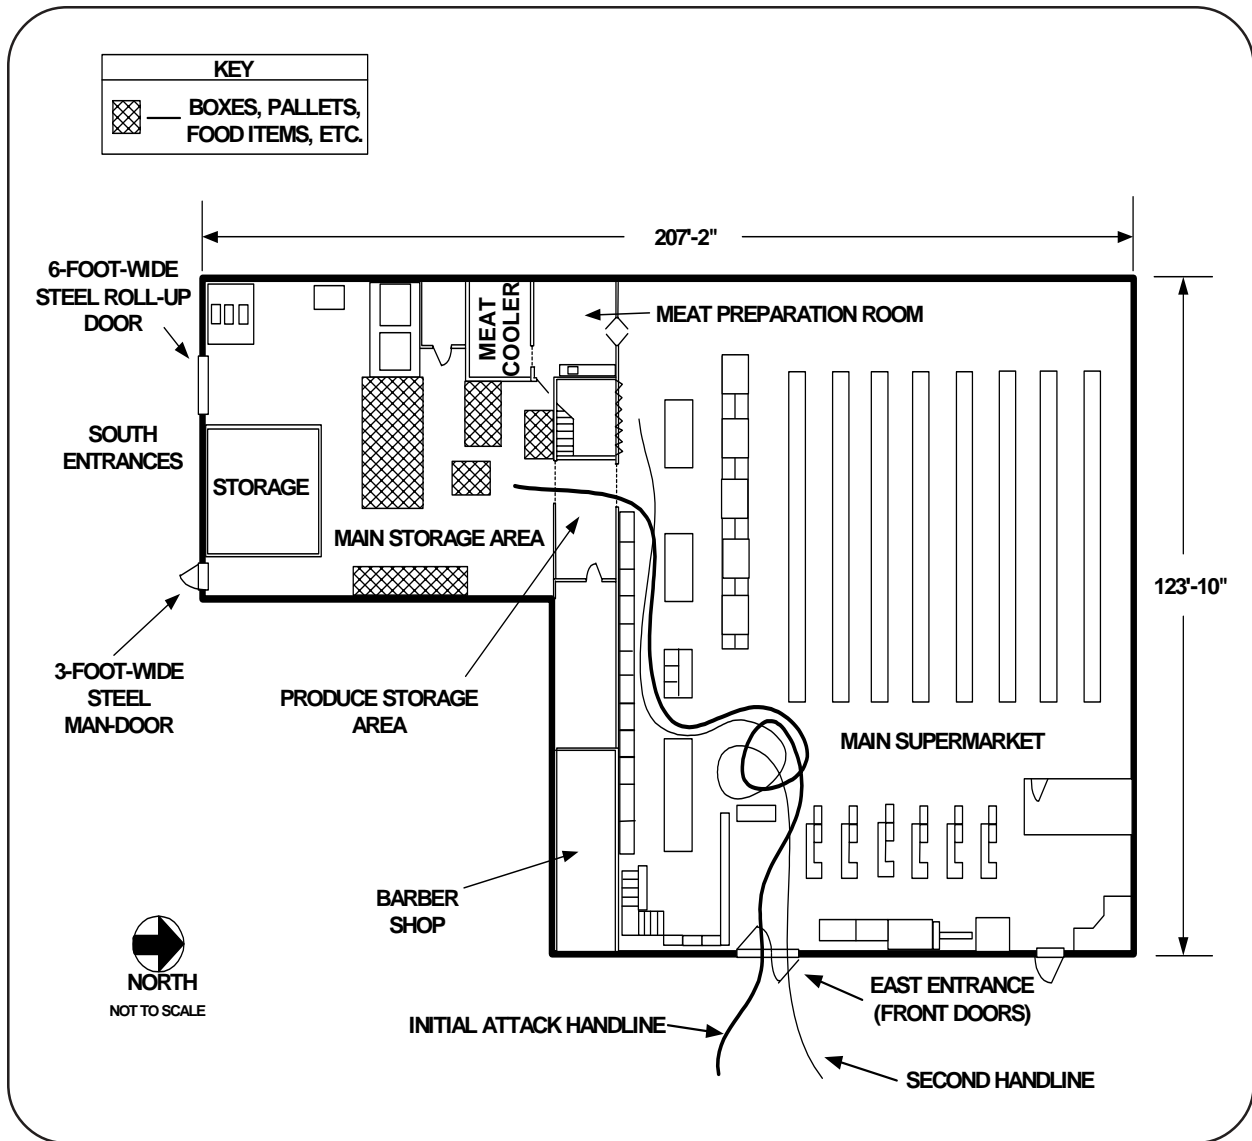
Diagram 2. Supermarket Layout

At 1714 hours, Engine 14, Engine 3, and Rescue 3 advanced a handline into the produce storage area, and Engine 3 advanced a second handline through the supermarket toward the meat preparation room, which was located along the west wall of the structure (Diagram 2). Conditions in the supermarket

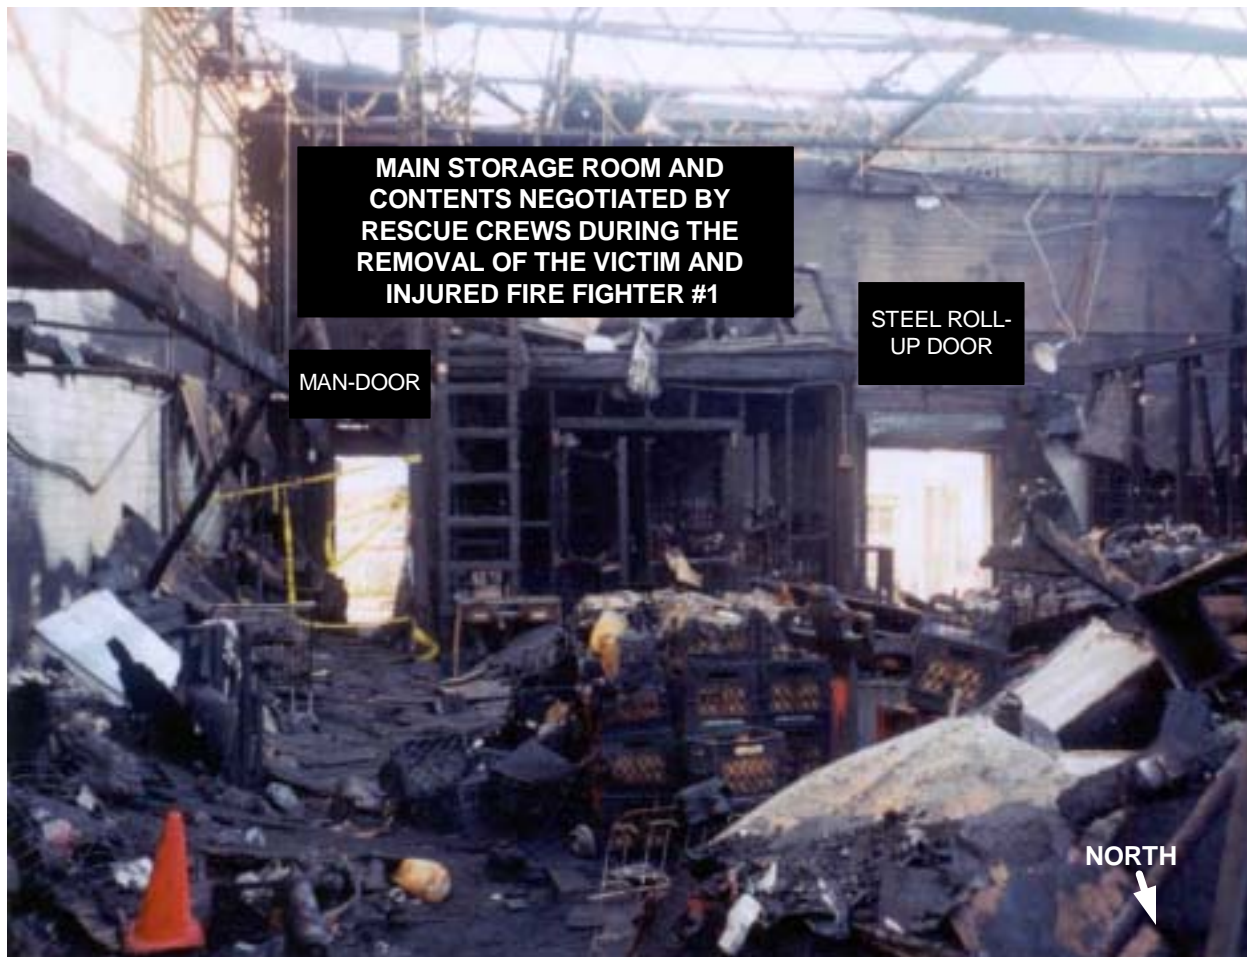
Photo 2. Main Storage Room

NOTE: The IC and first-arriving units were unaware that the supermarket was L-shaped and could be accessed from the east and south sides of the building. The east side was the main entrance to the shopping area of the supermarket and the south side—directly behind the clothing and hardware stores—was the location of the man-door and roll-up door entrances to the main storage area of the supermarket (Photo 2).

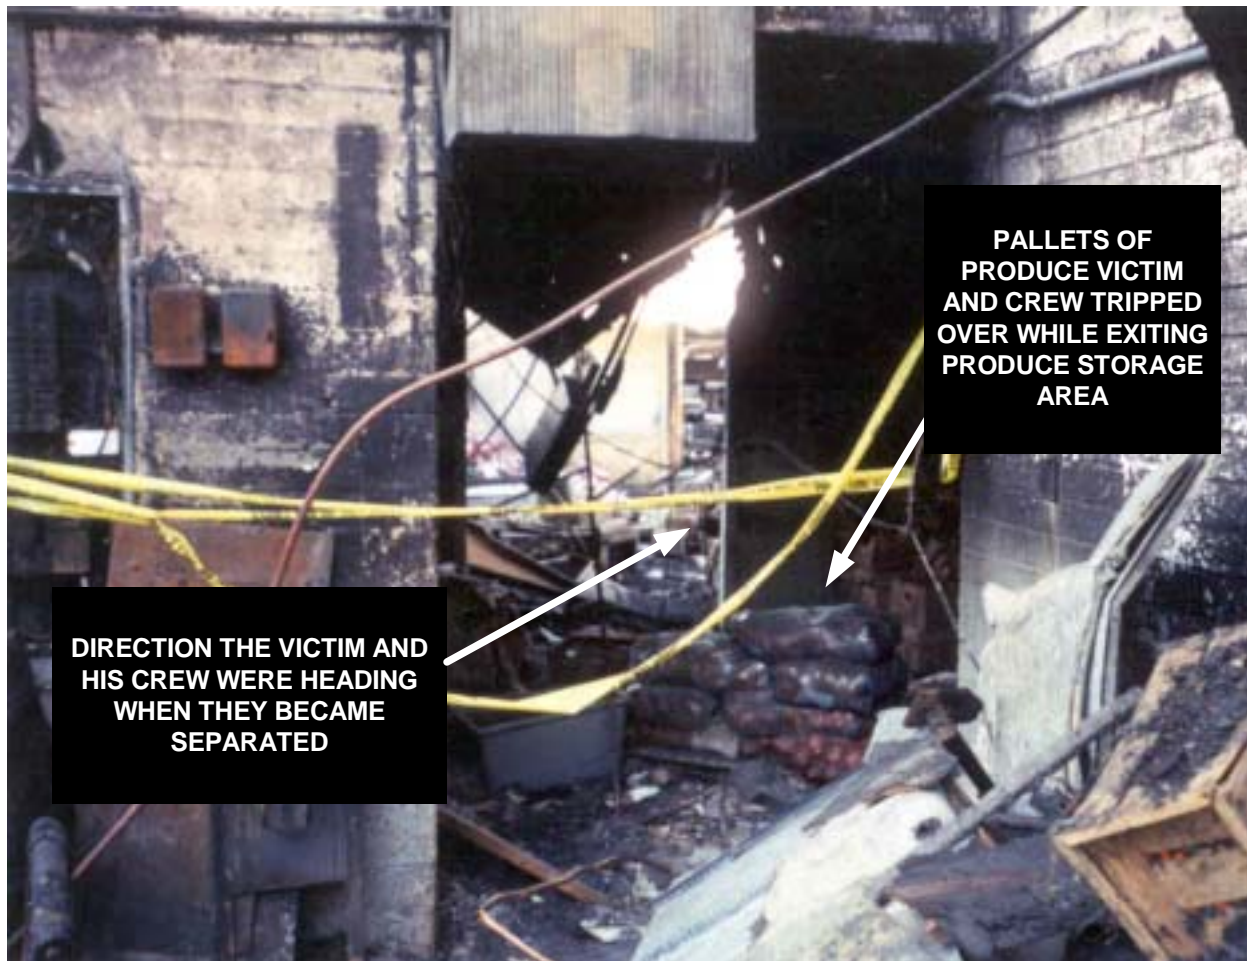
Photo 3. View of Produce Storage Area

deteriorated as the structure began to fill with thick, black smoke. The crew from Engine 14, an officer and fire fighter from Engine 3, and a fire fighter from Rescue 3 were operating in the produce storage area (Photo 3). Another fire fighter from Rescue 3 (Injured Fire Fighter #1) and crew members from Engine 3 were on the second handline in the supermarket. *NOTE: The crew from Ladder 24 cut a 6-foot by 6-foot ventilation hole in the roof over the storage area and then exited the roof because they were running low on air.*
