Fire Engineering®

Our Lady of the Angels School Fire: Part I **Article by Gregory Havel**

December 3, 2012

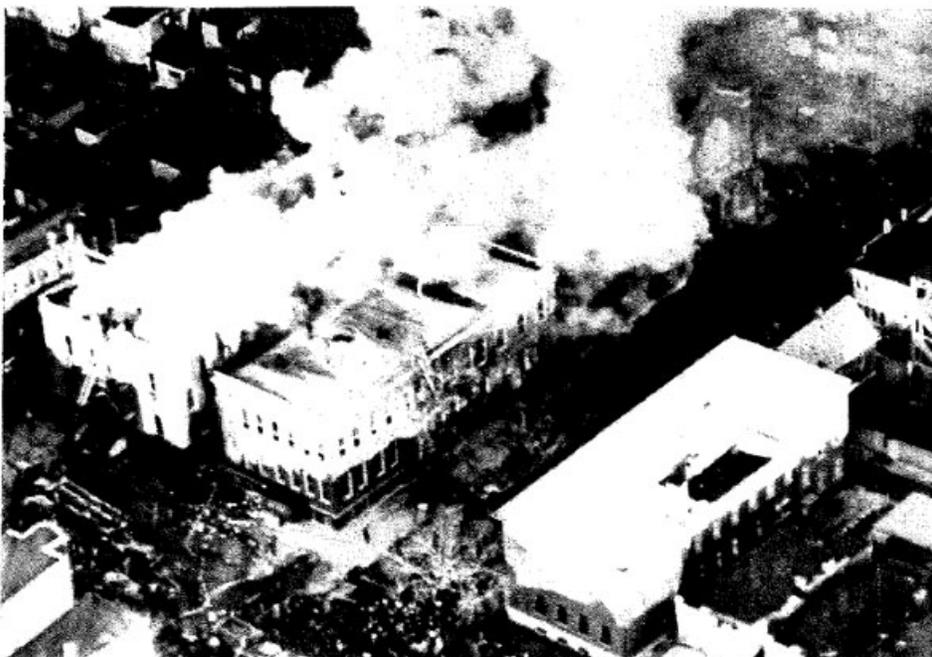
At the same time, a pipe chase running between the basement and the cockloft above the second-floor false ceiling acted as a chimney for superheated gases, which filled the cockloft. The temperature rapidly rose until it ignited the exposed wood framing in these concealed spaces. The fire swept through the second floor corridor in the north wing of the school at the same time that the cockloft above the classrooms flashed over.

Aerial view of fire shows U-shaped construction of school. Fire was confined to north wing. School is located in closely built-up northwest side of the city
