# Fire Engineering®

## Construction Concerns: Wood-frame Lean-over Collapse

Article and photos by Gregory Havel

March 26, 2009

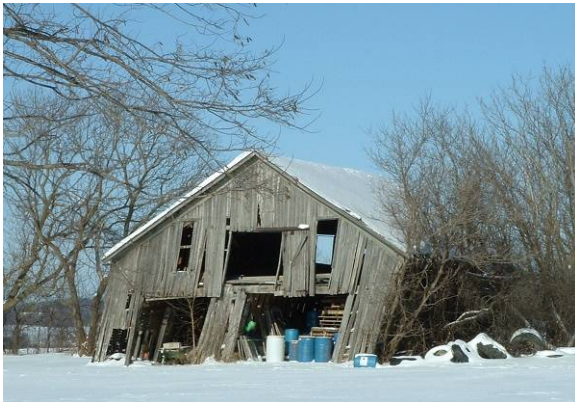
Photo 1 shows a barn during a lean-over collapse. It can no longer stand by itself and is partly supported by the trees to its right, and partly by its contents. Without these secondary supports, the century-old nails would fail and gravity would complete the collapse.

In a rural area, a building’s collapse in this way may seem less significant than if it occurred in an urban area with neighbors (exposures). However, we must keep in mind that this barn is already unhealthy; and that if there is a fire, we do not want to be on top of or under the structure while it finishes its collapse.

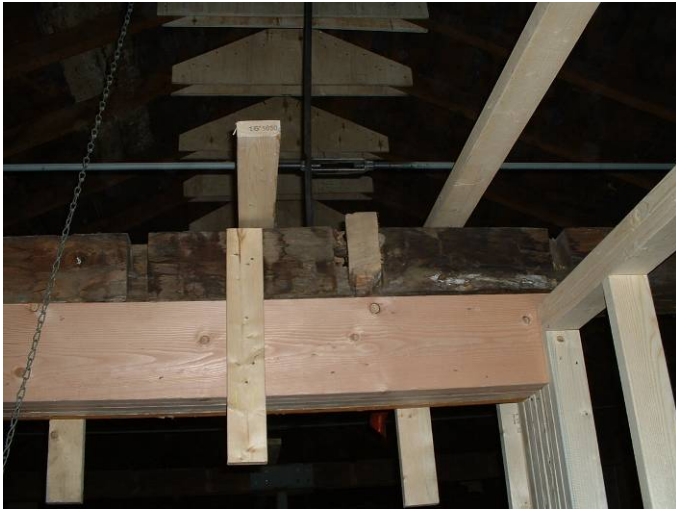
Photo 2 shows part of the attic and second floor of a post-and-beam structure built in the 1860s. During this most current restoration, the architect designed several steel-rod turnbuckles to stabilize the building frame, which was beginning to lean toward the street.

Although this building now has vertical walls and horizontal floors and is an attractive part of the historical preservation district, we must remember that these rods will elongate and loosen when heated in a structure fire, returning the building to its previous instability, the result of aged and loosened mortise-and-tenon joints.

Photo 2 also shows new white plywood gusset plates nailed to the rafters at the underside of the ridge. This building was unusual for the era, since the top ends of the rafters were nailed directly to each other, without a ridge-board.

The presence of steel rod or cable turnbuckles and the absence of a ridge board in the roof framing should be significant enough to note on our prefire plan for this building. If a fire were to go beyond the contents of a single room, we should be prepared for a lean-over building collapse. We should also expect the roof to be as unsuitable for roof-ladder work as if it were built on wood trusses.
