Construction Concerns: Trusses Article by Gregory Havel

February 27, 2013

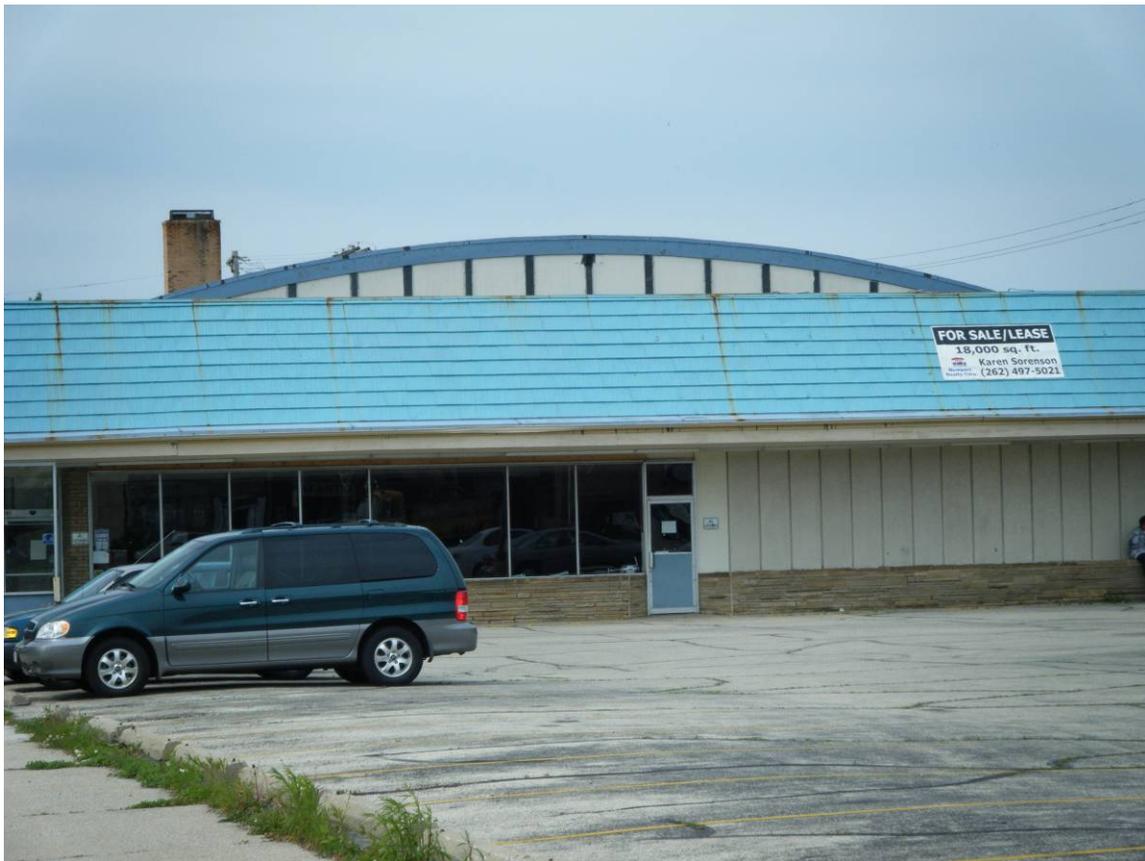
Sometimes we get the impression from news stories and even from firefighting textbooks that the truss is a recent development in construction, and that the bowstring truss (photo 1) is the most hazardous in a fire.

The structure in photo 1 was built around 1960, and used the bowstring truss so that there would be a large unobstructed floor area for retail sales and so that the roof would easily shed rain and melting snow. These trusses are usually built of either wood or steel, although some have wood for the top and bottom chords and steel for the web members. Bowstring trusses were originally designed for bridges, but became popular during World War II to support the long roof spans of aircraft hangers and manufacturing facilities.

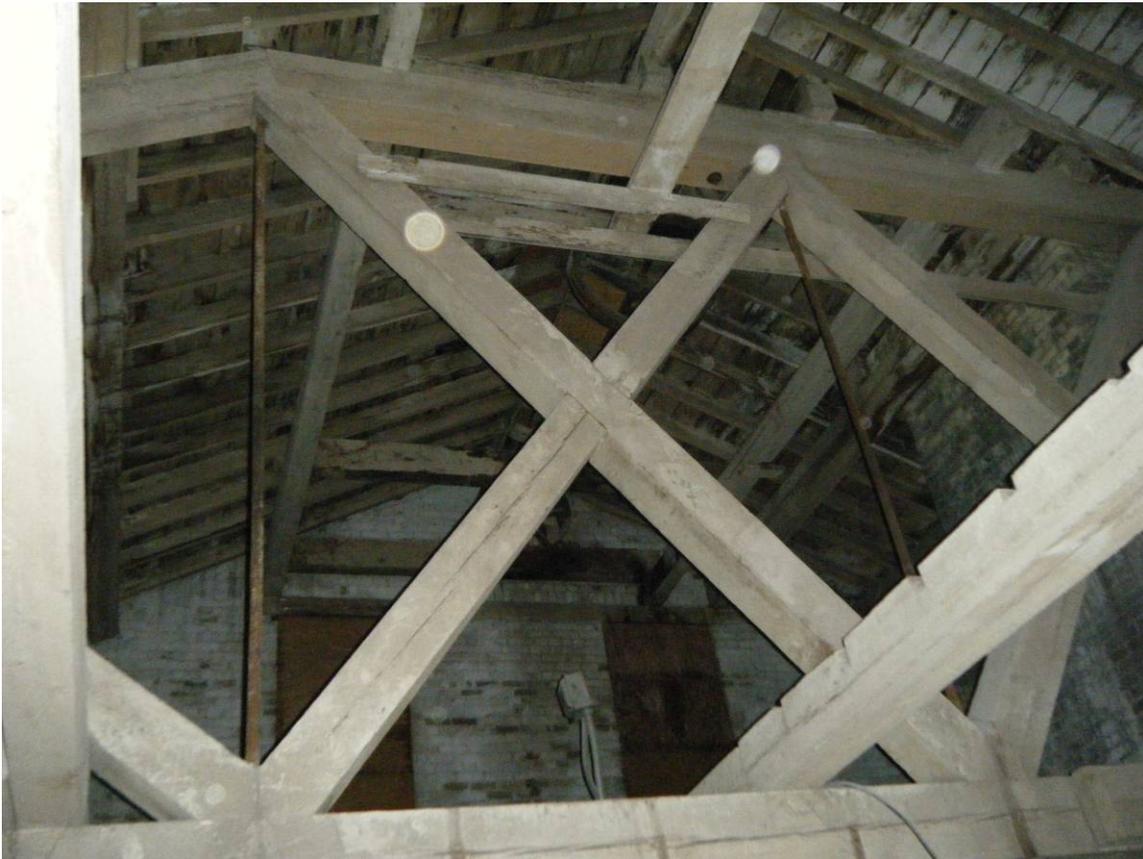
Trusses have been in common use in North America since before 1800. Some truss designs were developed for bridges and adapted for use in buildings. Photo 2 shows a timber roof truss in a “mill” (the ancestor of modern Type IV or heavy timber) building from 1840. The compression members of this truss are of wood, ranging from 8 x 8 inches to 12 x 12 inches (20.3 x 20.3 cm to 30.5 x 30.5 cm). The tension members of

this truss are wrought-iron rods. Search the Internet for “trusses” for information on their history and design.

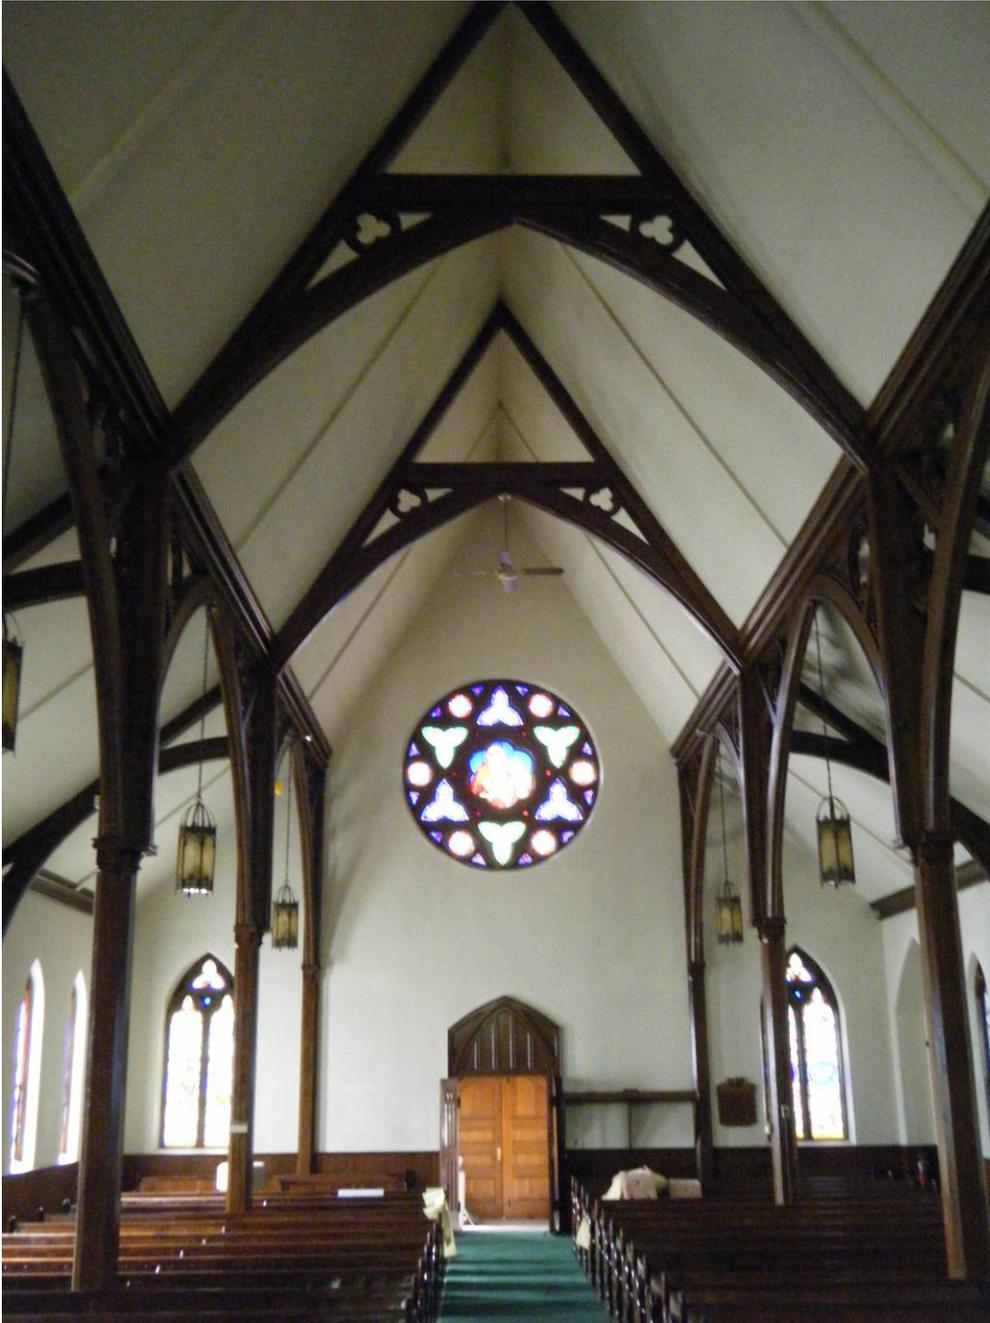
Photo 3 shows the trusses supporting the ceiling and roof assembly of a church, built in the late 1800s. The ceiling in this church is attached to the bottom of the same rafters that support the roof. These trusses are not only decorative—they support the ceiling and roof.
