# Fire Engineering®

## Construction Concerns: Combustible Building Exterior Article by Gregory Havel

*January 8, 2013*

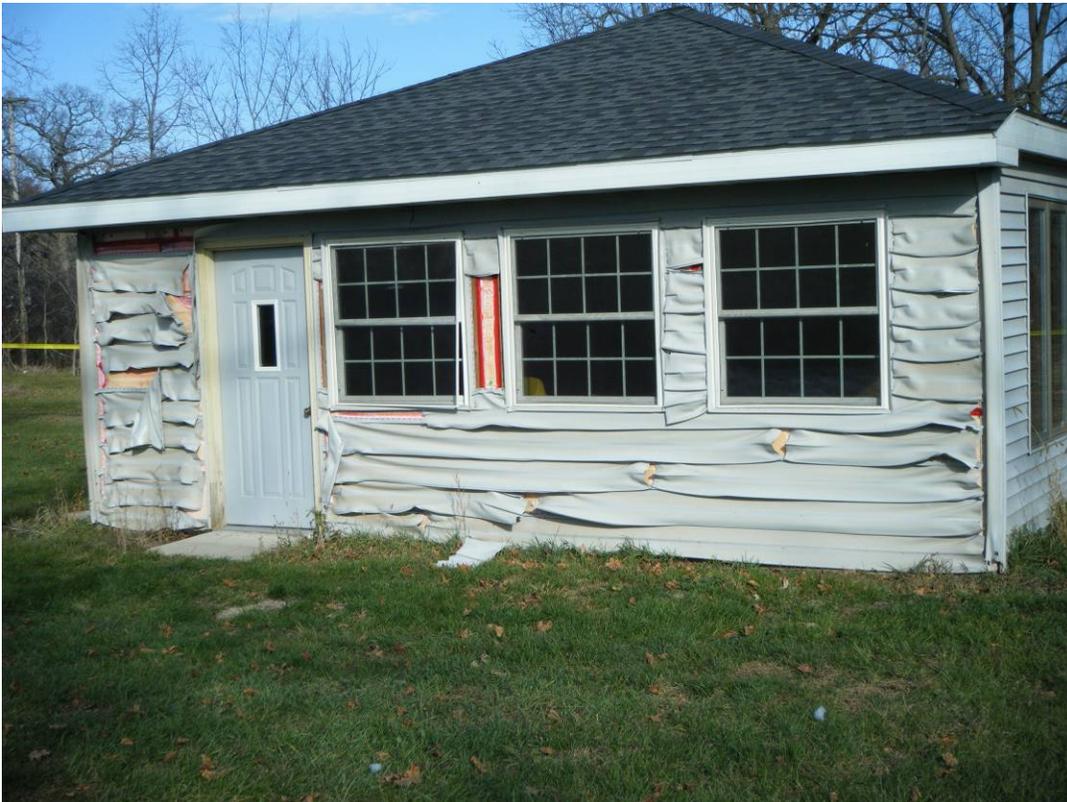
When we arrive at a working structure fire, the flames and smoke attract our attention, and we are sometimes distracted from noticing the exposures with combustible exterior finishes (photo 1). A large body of fire produces enough radiant heat to easily melt vinyl siding at a distance of 40 feet (12.19 m) (photo 2, next page), and even to ignite it. Aluminum siding will soften and sag similarly, but will not ignite. Wood siding will ignite at a temperature higher than that which will damage aluminum and vinyl siding, but it will not melt.

At the structure fire shown in photos 1 and 2, the fire started on the first floor of a two-story, balloon-framed farm house, and developed and spread so rapidly that by the time the smoke and smoke detectors awakened the second-floor residents, they were forced to exit through the second-floor windows rather than by the stairway and exit door. By the time the fire department arrived, the house was fully involved, and the exposure's siding was already damaged.

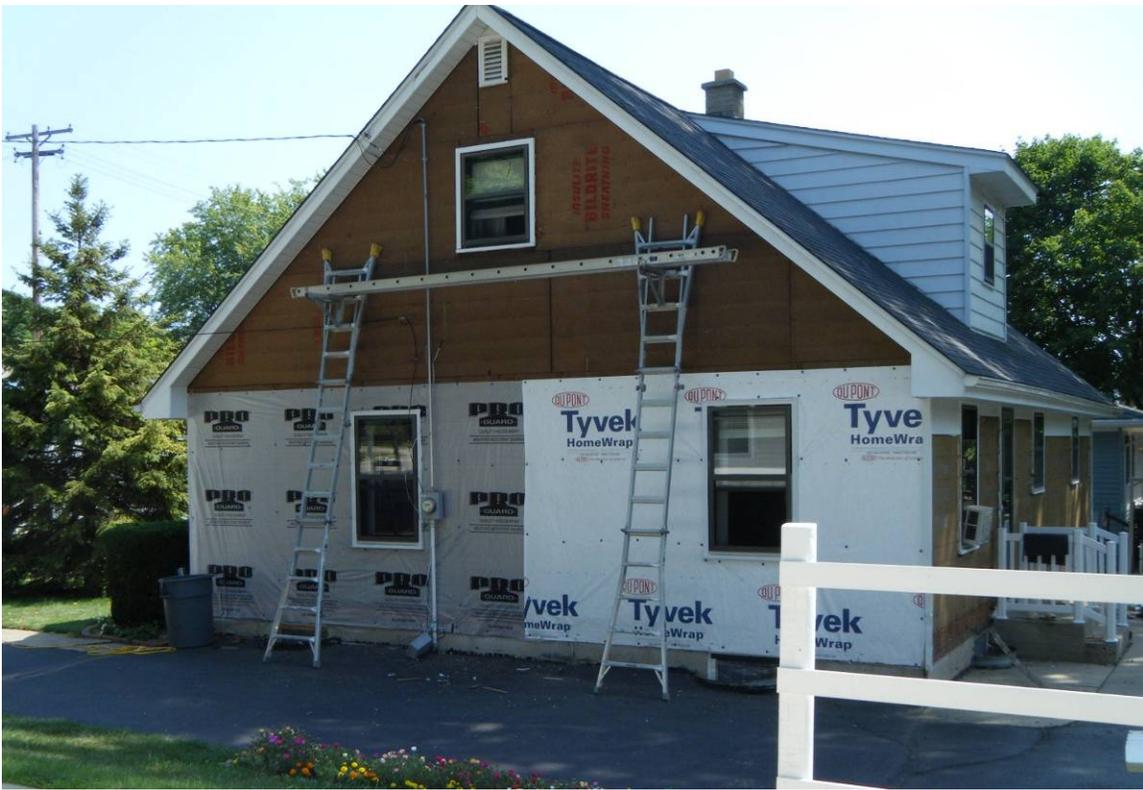
Photo 3 shows a 1960s platform-framed house that is undergoing exterior renovation.

- The original aluminum siding (still in place on the dormer) has been removed, exposing the combustible asphalt-impregnated low-density fiberboard sheathing that is visible on the gable.
- At the first floor level, this original sheathing has been covered with polystyrene insulating board and a layer of polyolefin structure wrap, which will be extended up to the gable.
- The new exterior will be vinyl siding.
- Although the polystyrene insulating board, the structure wrap, and the vinyl siding include a fire retardant, they will still burn rapidly in a vertical orientation, with a continuous source of ignition.
