Continuing Education Course

Structural Collapse: The Hidden Dangers of Residential Fires

By James M. Dalton, Robert G. Backstrom, and Steve Kerber

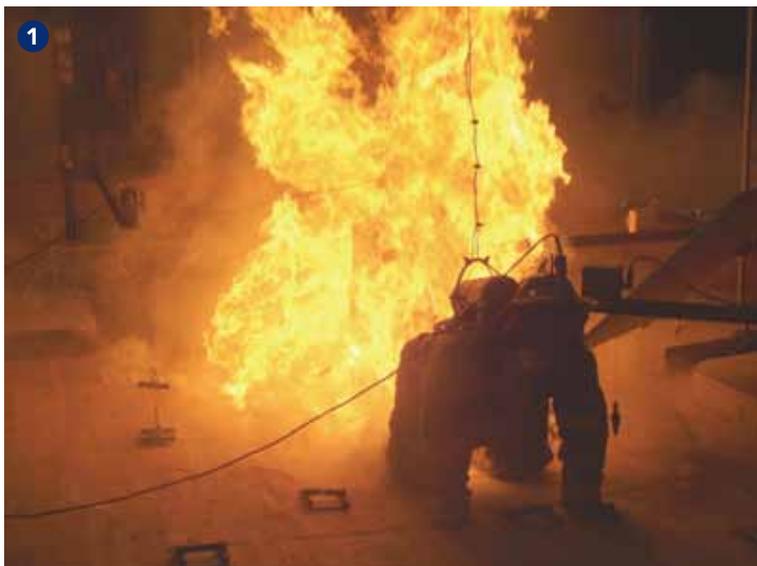
(1) A standing firefighter mannequin is engulfed in flames as he falls through the floor assembly behind the crawling firefighter mannequin. (Photos courtesy of authors.)

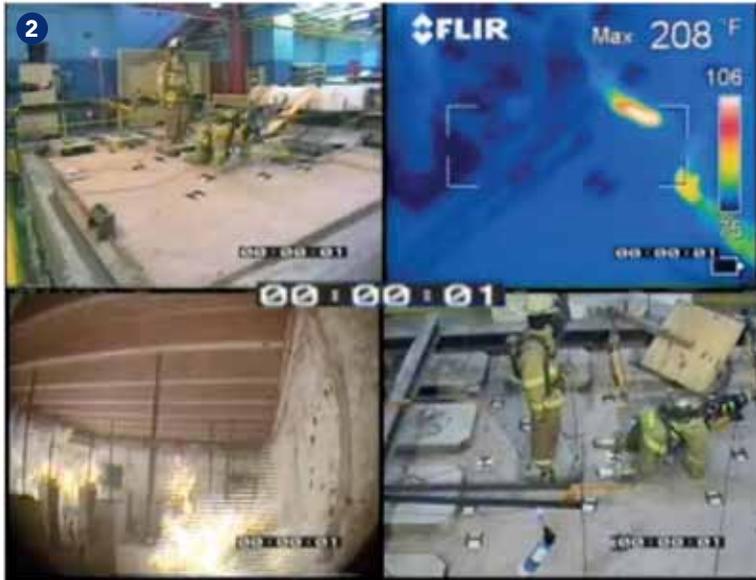
(2) A quadrant view of recorded video images taken during the experiments available in the Web-based outreach program.

All of this information could not be included in a single article or report, so it has been developed into a Web-based outreach

program for the fire service. This free interactive program is at www.ul.com/fire/structural.html.

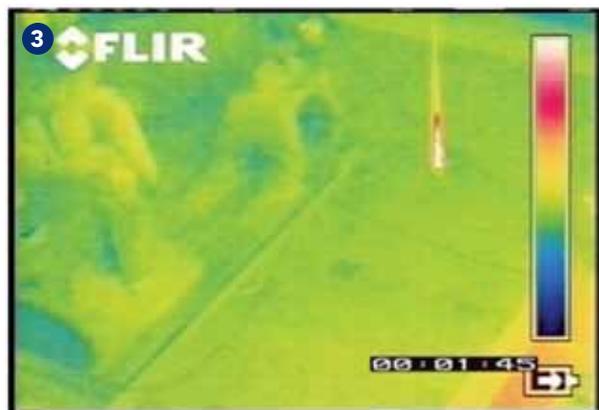
(3) Thermal imaging camera image and temperature measurement of legacy 2 x 10 joist floor—without ceiling at 1:45. Left: The thermal imaging camera view. Right: Temperature measurements above and below the finished flooring.

Thermal imaging cameras do not provide an adequate indication of a weakened floor or pending collapse. There is a potentially dangerous misconception in the fire service that TICs can detect fire on the floor below or above a firefighter. TICs detect variations in surface temperatures for objects in the field of vision. They cannot detect temperatures if the camera is thermally shielded by the finish materials of a floor or ceiling, such as carpet or gypsum board. Average temperatures below the assembly were in excess of 1,200°F while average temperatures on top of the carpet were less than 100°F. The application of water during suppression operations will also further mask these thermal signatures in the TIC camera’s field of vision during suppression operations.

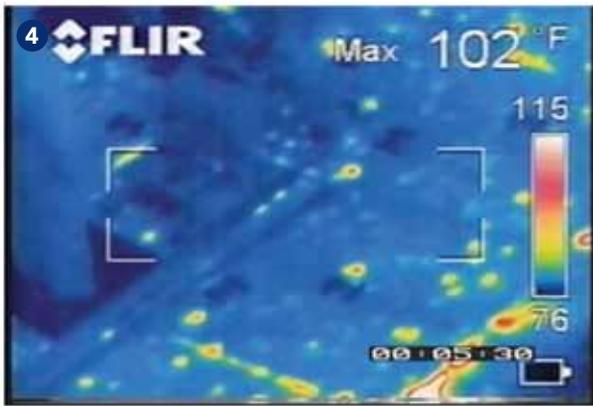
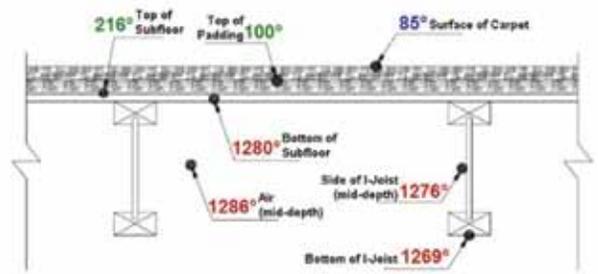
(4) Thermal imaging camera image and temperature measurement of modern lightweight 12-inch wood I-Joist floor—without ceiling at 5:30, just prior to the floor collapse. Left: The thermal imaging camera view. Right: Temperature measurements above and below the finished flooring.

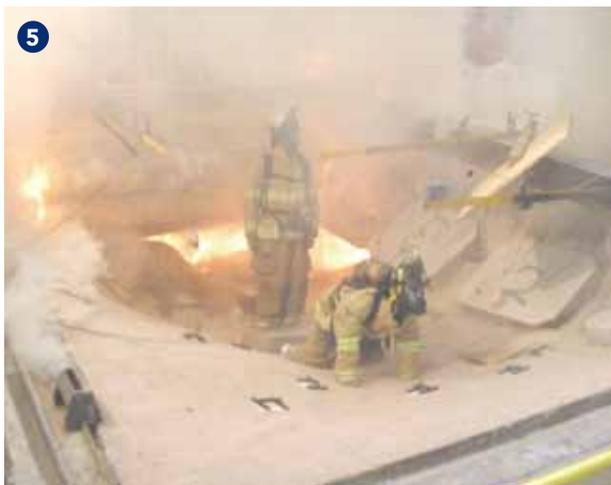
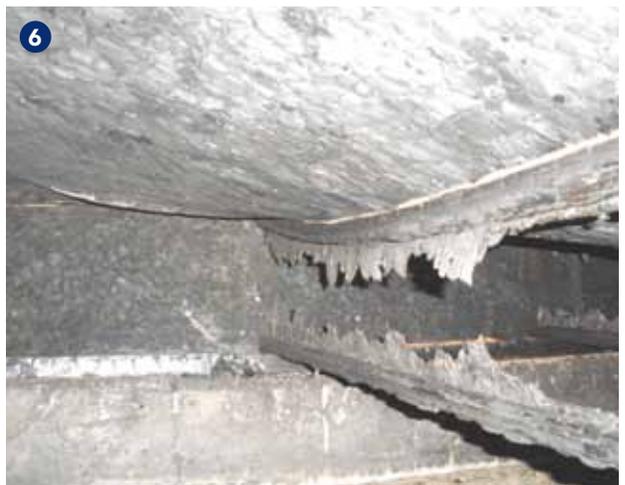
A modern lightweight 12-inch wood I-joist floor—without ceiling. Collapse Time = 06:03. (5) The excessive floor deflections at the time of failure. (6) The condition of one of the surviving engineered I-joists after extinguishment.

collapse time. If the ISO standard was applied to the unprotected engineered wooden I-joist assembly, the accepted failure time would change from 06:03 (acceptance criteria time per the ASTM E119 standard) to 04:00 (load-bearing capacity per the ISO 834:1 standard). For the fire service, this means that a complete collapse of this floor would have been seen at 06:03 but that the floor would have been severely compromised and potentially unsafe to operate on at 04:00. Be aware that although these testing methods provide documented research failure times, they also illustrate that the floors have become dangerous far before the actual documented collapse times. This trend was consistent throughout the engineered lumber assemblies tested within this study. These failures in real-life incidents may also be accelerated by larger fire loads and variations in field conditions.

A review of the ASTM E119 and ISO 834:1 failure times as they apply to the unprotected (without ceiling) engineered wooden I-joist assembly clearly illustrates that the floor had become significantly damaged and lost its ability to carry load far before the actual total

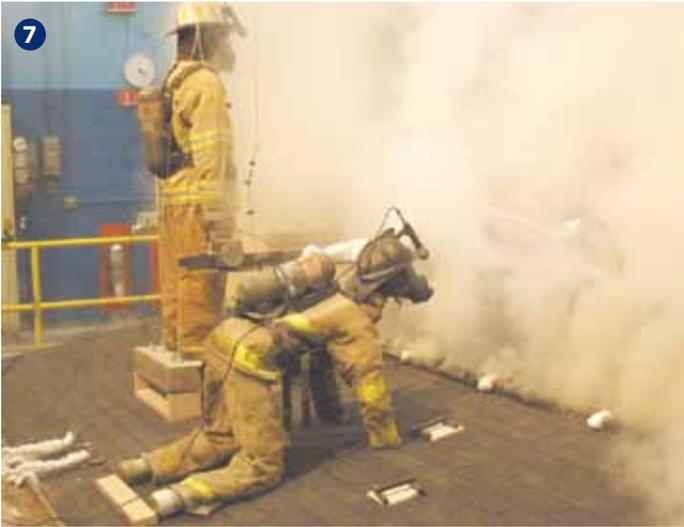
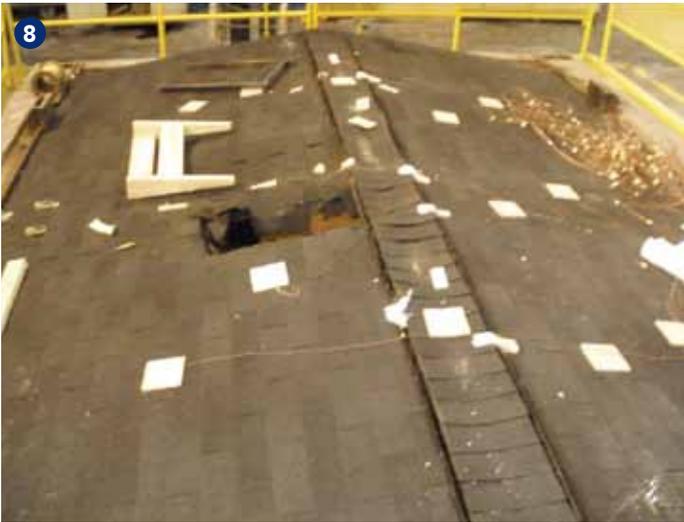
Modern lightweight metal gusset truss roof—with ceiling. Collapse Time = 23:15.

(7) A significant volume and velocity of smoke during initial portions of the test.

(8) The collapse of the continuous plastic ridge vent.

The study, however, did demonstrate a potentially dangerous and misleading ventilation phenomenon regarding installed roof vents. Initially, there was a significant amount of smoke emitting from the continuous plastic ridge vent at the beginning of the modern roof assembly test. As the temperatures increased, the continuous plastic ridge vent melted and collapsed. The collapse of the vent changed the ventilation profile for the roof. The initially heavy smoke pattern emitting from the continuous ridge vent diminished to a light indistinguishable smoke trail, although the fire was still raging below. The excessive heat created by the fire was, in effect, restricted from venting vertically through existing natural openings and created an excessively untenable condition below the roof in the attic and the occupied floor areas below the attic as the ceiling finishes failed.

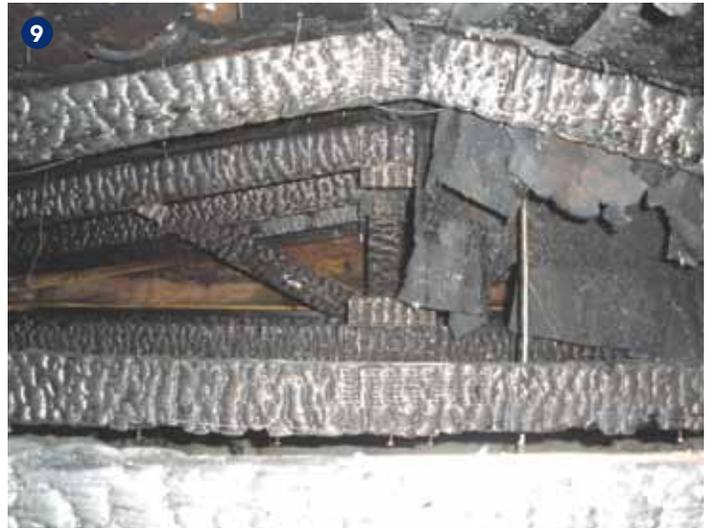
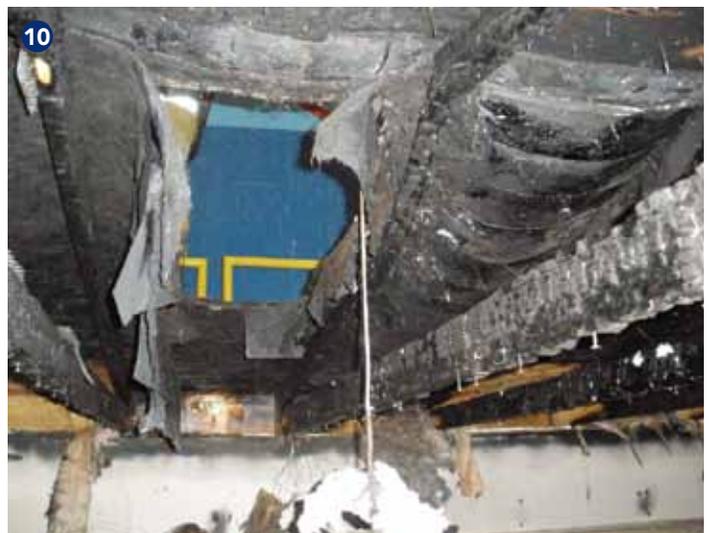
Modern lightweight metal gusset truss roof—with ceiling. Collapse Time = 23:15.

(9) Multiple metal gusset plate and web member failures.

(10) The deterioration of roof sheathing and ultimate failure of the roof sheathing and shingle materials.
